NATIONAL AERONAUTICS AND SPACE ADMINISTRATION

APOLLO 8 MISSION REPORT

MANNED SPACECRAFT CENTER  
HOUSTON, TEXAS  
FEBRUARY 1969

Mission Evaluation Team

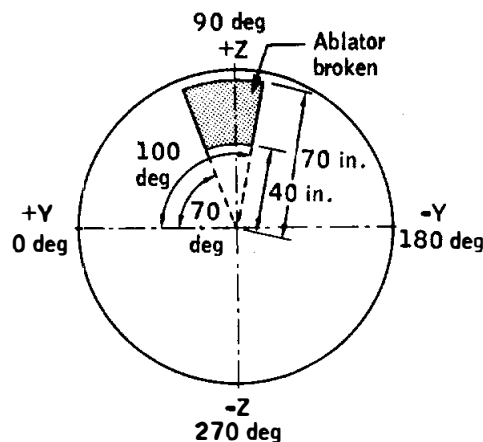
Figure 6.4-1.- Location of damaged ablator.

The condition of crew-compartment heat-shield components is very good. Umbilical bundles were cleanly severed, and discoloration on the window, plus blistered splotches on identification decals, are the only indications of entry heating on the unified hatch. All other crew-compartment and forward-heat-shield components show entry effects similar to or less severe than those observed on Apollo 4 and 6.

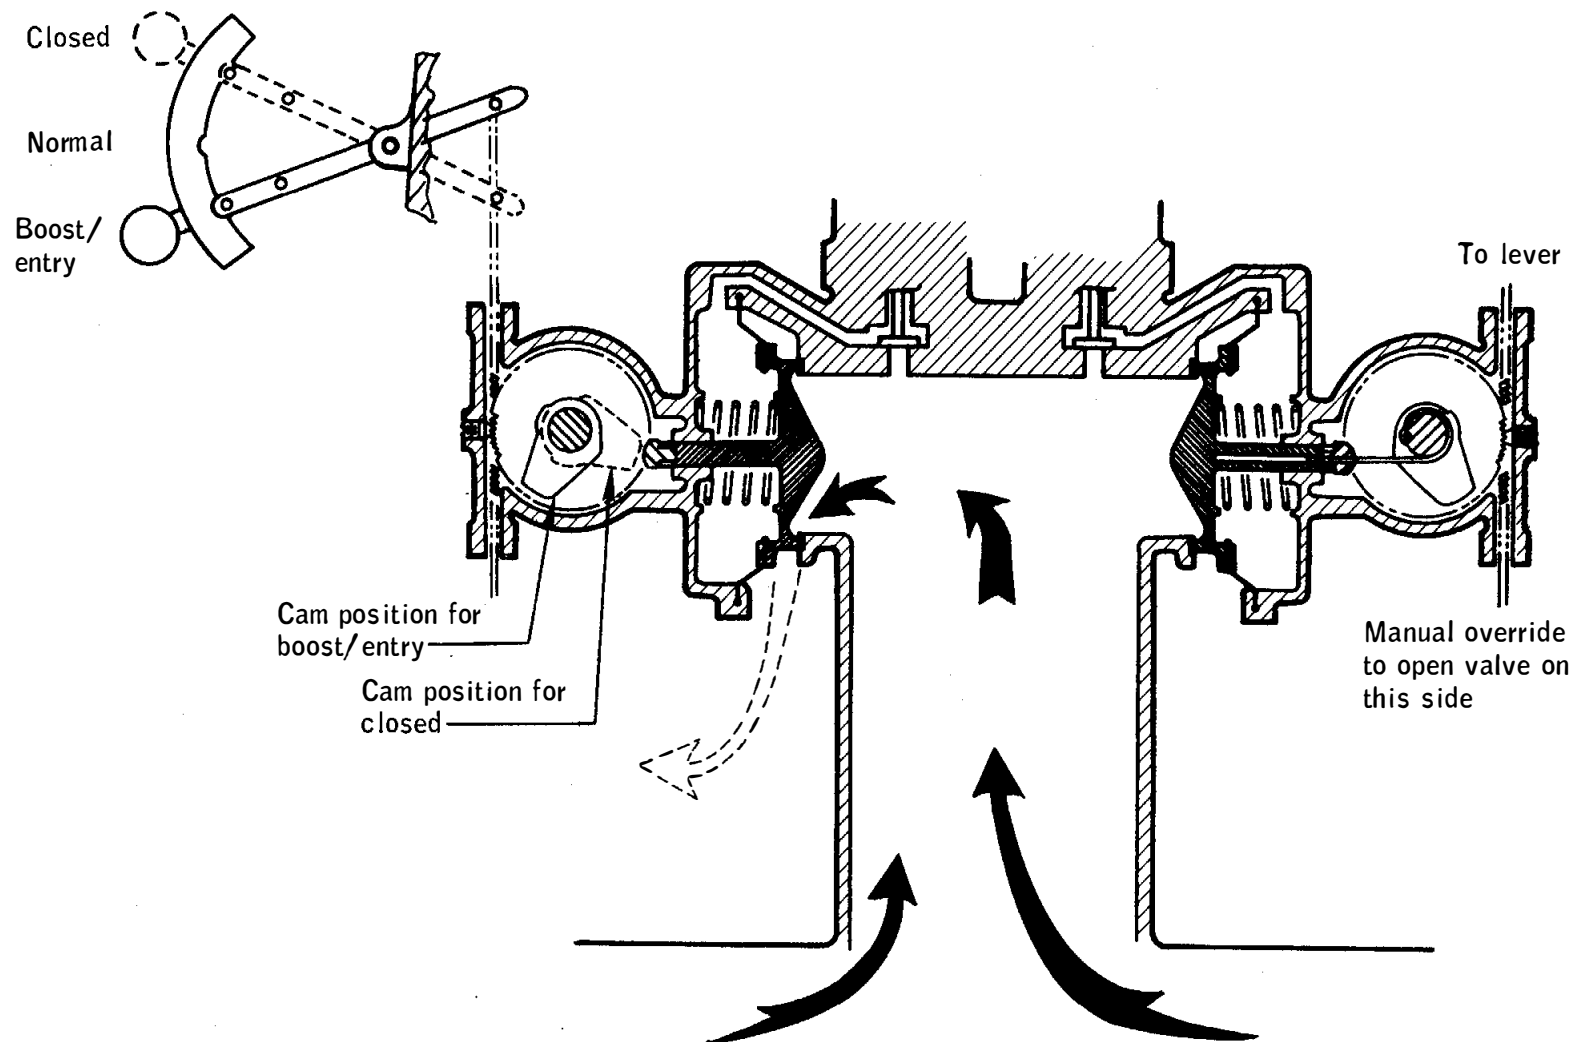
Figure 12-4.- Cabin pressure relief valve.

The crew estimated 2 to 3 quarts of water entered the cabin through the cabin pressure relief valve at landing. Postflight tests were conducted on the valve installed in the spacecraft. Test results indicate that, with both sides of the valve in the closed position, gaseous leakage through the system is 60 scc/min at a differential pressure of 18 inches of water. The differential pressure was increased up to 13 psi, with no significant increase in leakage. Test results indicate that the valve operated as designed and would not have allowed water ingestion if properly closed.

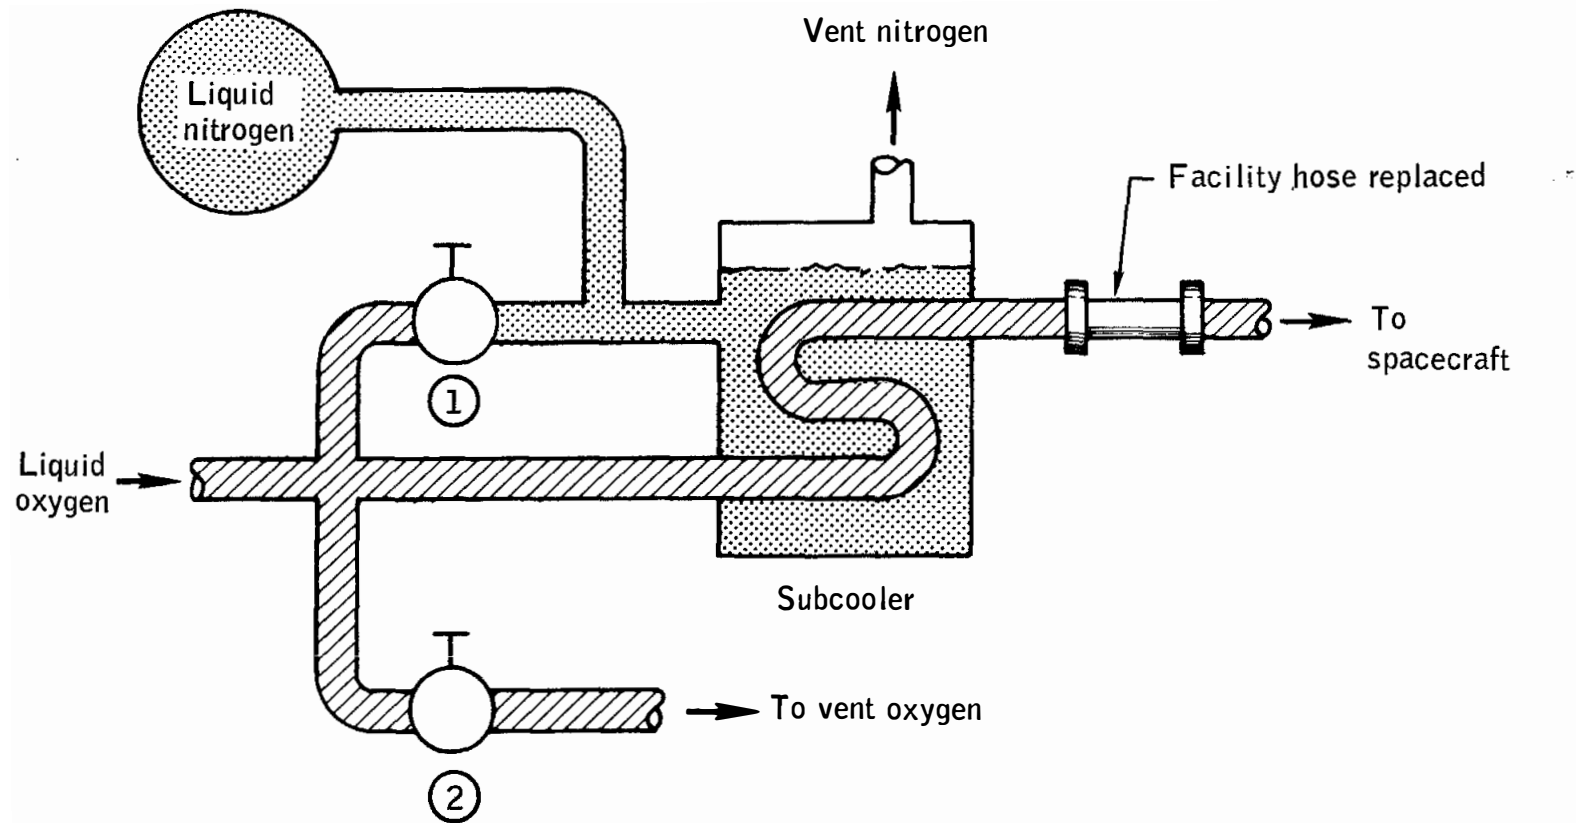
Figure 12-9.- Simplified schematic of cryogenic oxygen servicing unit.

During normal servicing operation, liquid oxygen flows through a subcooler, which is chilled by liquid nitrogen. Valves 1 and 2 are closed during this operation.

While servicing liquid oxygen, a leak developed in a facility liquid oxygen line, causing a safety shutdown. To preclude overpressurization because of stagnant liquid oxygen, the system was vented using the normal shutdown procedure. This procedure was incorrect in one area, which called for opening valve 1 instead of valve 2. This error allowed liquid nitrogen to flow through valve 1 into the liquid oxygen supply line. Procedures have been corrected and verified by test. This anomaly is closed.
