NATIONAL AERONAUTICS AND SPACE ADMINISTRATION

APOLLO 8 MISSION REPORT

MANNED SPACECRAFT CENTER  
HOUSTON, TEXAS  
FEBRUARY 1969

Mission Evaluation Team

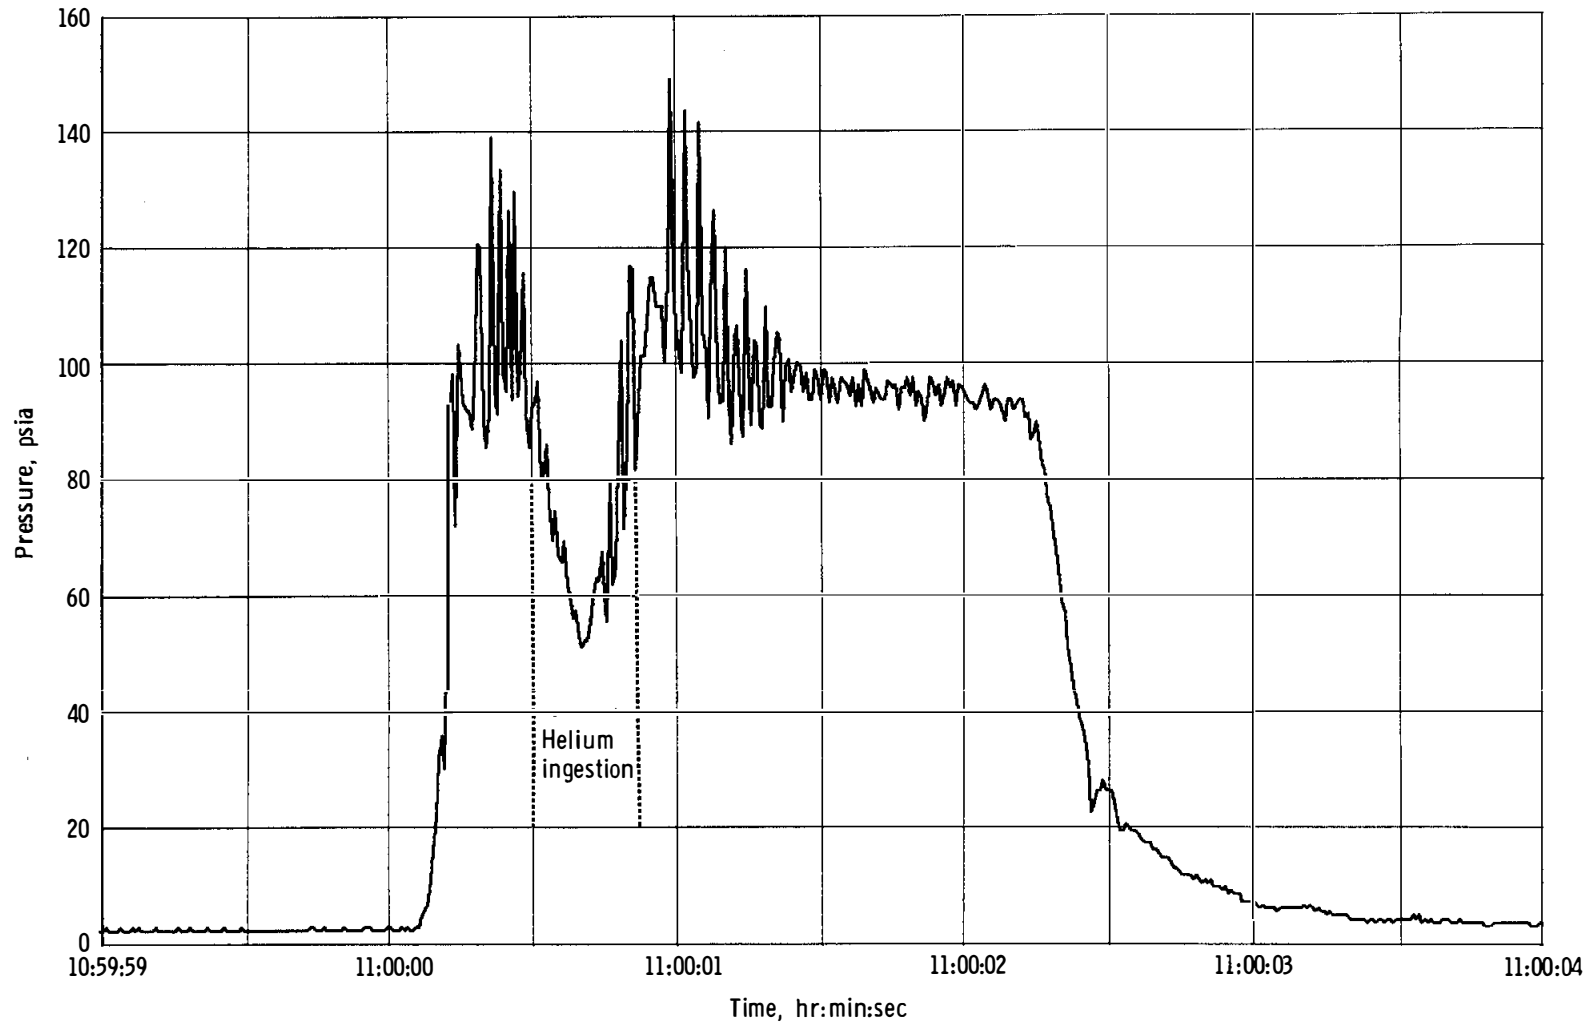
Figure 6.11-1. - Chamber pressure during first service propulsion maneuver.

A momentary drop in chamber pressure (fig. 6.11-1) was observed at the start of the first maneuver; this drop is attributed to the presence of a helium bubble in the oxidizer feed line. The trapped helium resulted from an inadequate engine-oxidizer bleed during preflight servicing. Comparable chamber pressure traces were obtained during a spacecraft ground test when the bleed procedure was also improperly conducted and during the AS-202 mission, during which the second service propulsion maneuver also exhibited helium ingestion. Chamber pressure characteristics were normal for the remaining three maneuvers. Bleed procedures have been changed in future spacecraft to preclude recurrence of trapped helium in the lines.

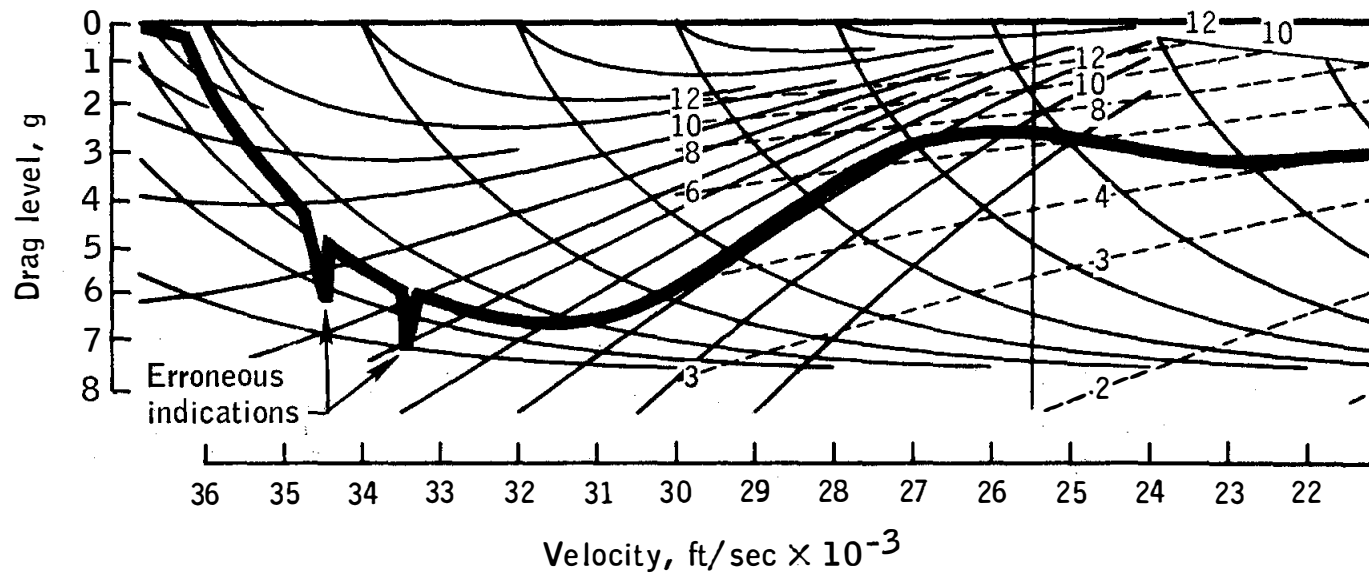
Figure 12-1.- Entry monitor system scroll.

1. During the spacecraft/S-IVB separation sequence, the delta V counter jumped 100 ft/sec.
2. For the third midcourse correction, a delta V of 5 ft/sec was entered into the entry monitor system. The system counted to zero at delta V cutoff; however, it continued to count after the maneuver and was finally turned off by the crew.
3. At times when the mode switch was rapidly switched from "stand-by" to "automatic," the delta V counter jumped 19 to 20 ft/sec.
4. For the initial entry phase, the g/velocity trace on the entry scroll showed two short, incorrect g transients (fig. 12-1). Operation of the scroll assembly was normal in all other respects.

The entry monitor system was removed from the spacecraft, and no abnormal indications were observed in functional tests. However, during tilt-table tests, abnormal accelerometer outputs were observed when random 0.25g pulses were produced at approximately 0.8g. Detailed testing and inspection of the accelerometer disclosed a bubble in the damping fluid. The bubble may explain the behavior of the g trace during entry and the random pulses during the tilt-table test. The bubble may also be associated with the problem after the midcourse correction, in that it has been demonstrated that the time for the accelerometer to drive to null greatly increases when a bubble is present.

The accelerometer case contained 1 cubic centimeter less fluid than when it was originally filled. Indications near the fill port are that damping fluid had leaked around the O-ring seal. The seal has been changed from a screw to a plug type for units to be flown on spacecraft 106 and subsequent.

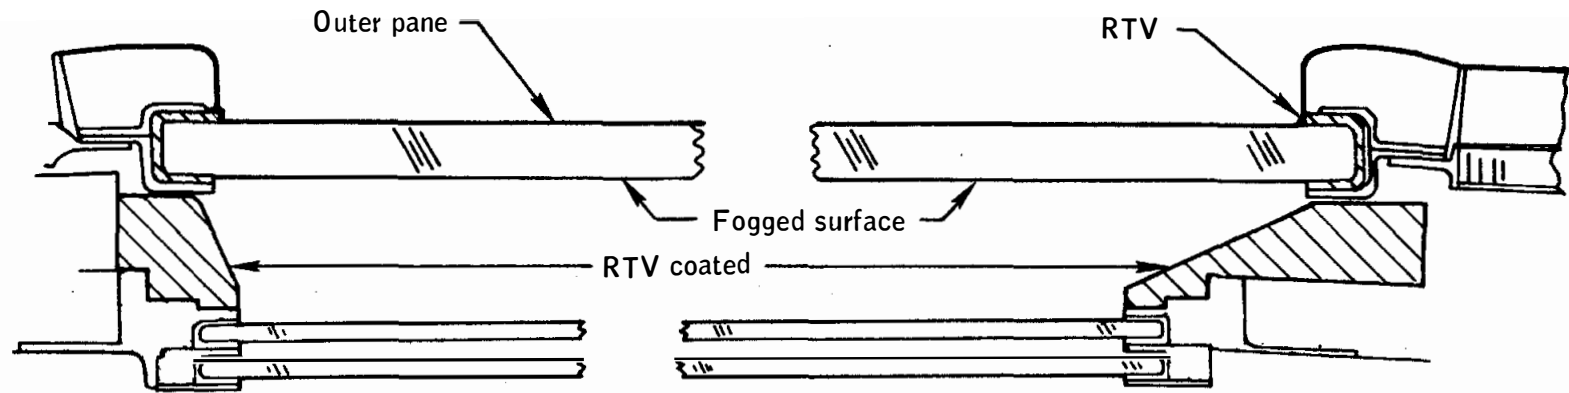
Figure 12-2.-Side window cross section (also typical for hatch window).

Visibility through the hatch window was degraded to the point that the window was useless for visual observation and photography after approximately 6 hours. The two side windows (1 and 5) were fogged but to a lesser degree. The two rendezvous windows (2 and 4) remained usable throughout the flight. These conditions were consistent with what was expected as a result of the Apollo 7 window fogging analysis, which showed the primary cause to be outgassing of silicone oils from the RTV sealing material.

Figure 12-2 shows a cross section of the side windows, including the typical installation of the three windows and the location of the modification. The modification consists of a new RTV curing process to greatly reduce the residual oils.

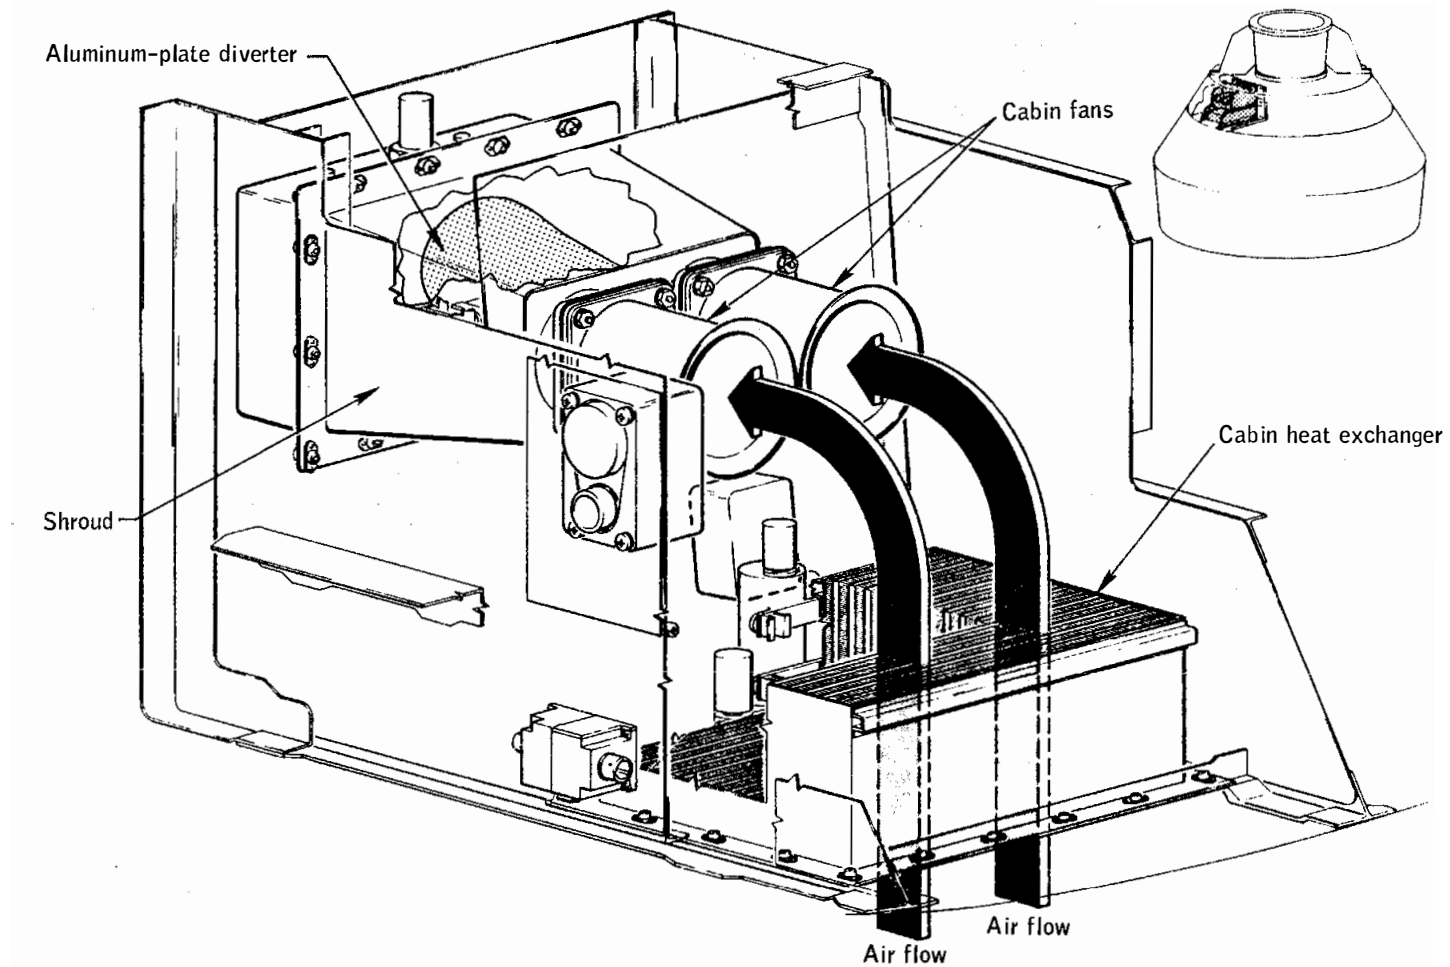
Figure 12-3.- Cabin fan installation.

During the sixth day of the mission, the cabin fans (fig. 12-3) were momentarily turned on, and the crew reported that both were noisy.

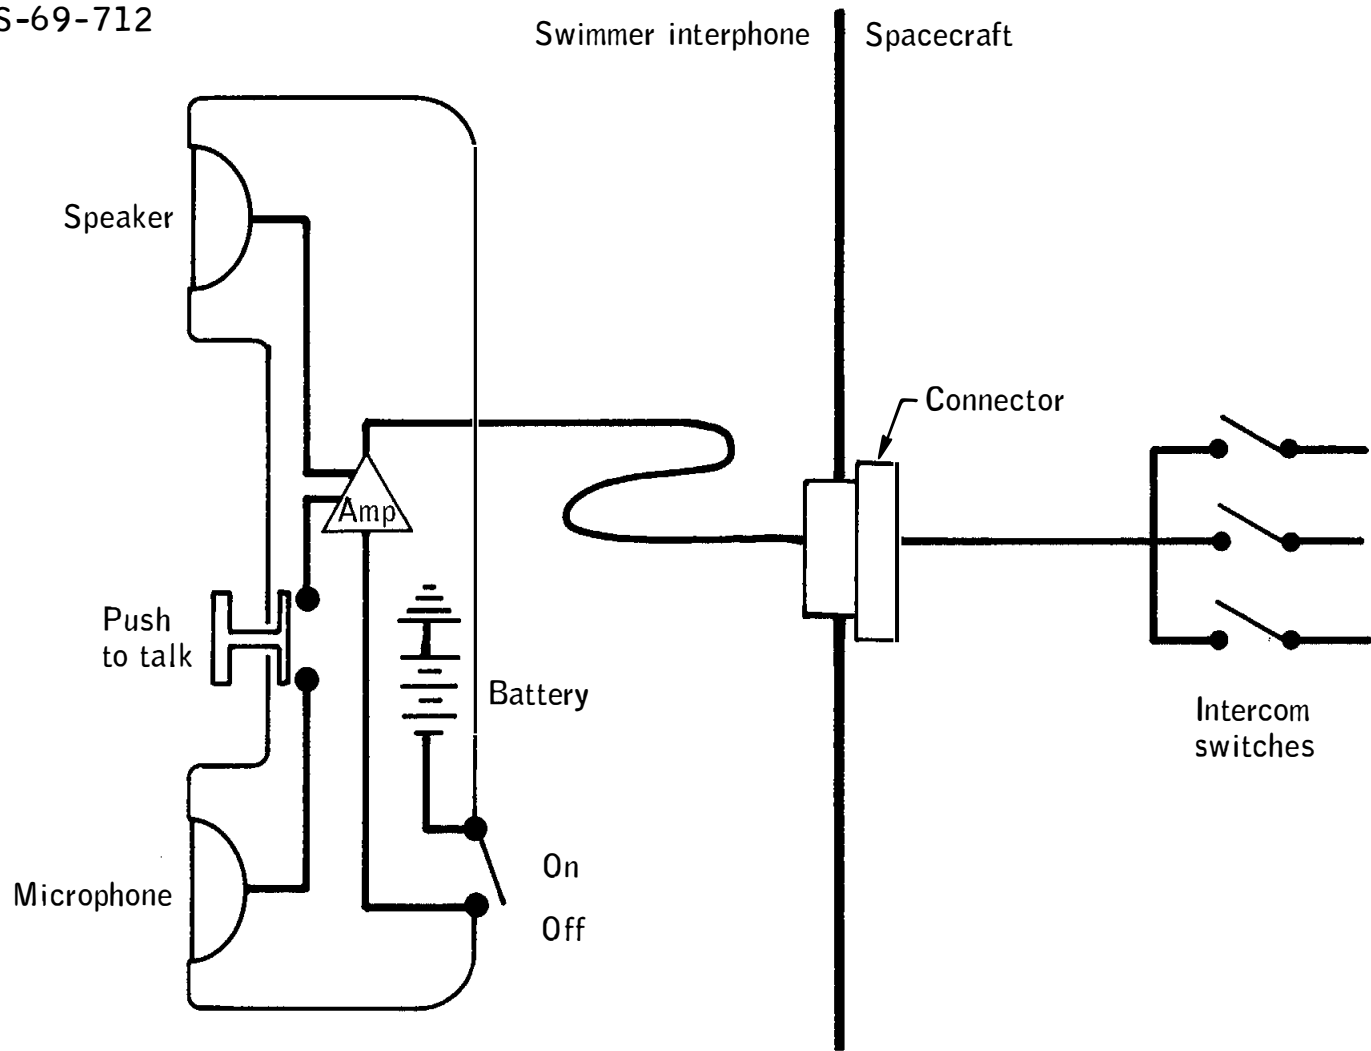
Figure 12-6.- Swimmer interphone.

During recovery operations, the swimmers were unable to communicate with the crew via the intercommunications system. The crew reported that the spacecraft intercom switches were in the proper position. As shown in figure 12-6, the swimmer interphone, which plugs into the spacecraft, has a push-to-talk switch and an ON-OFF switch.

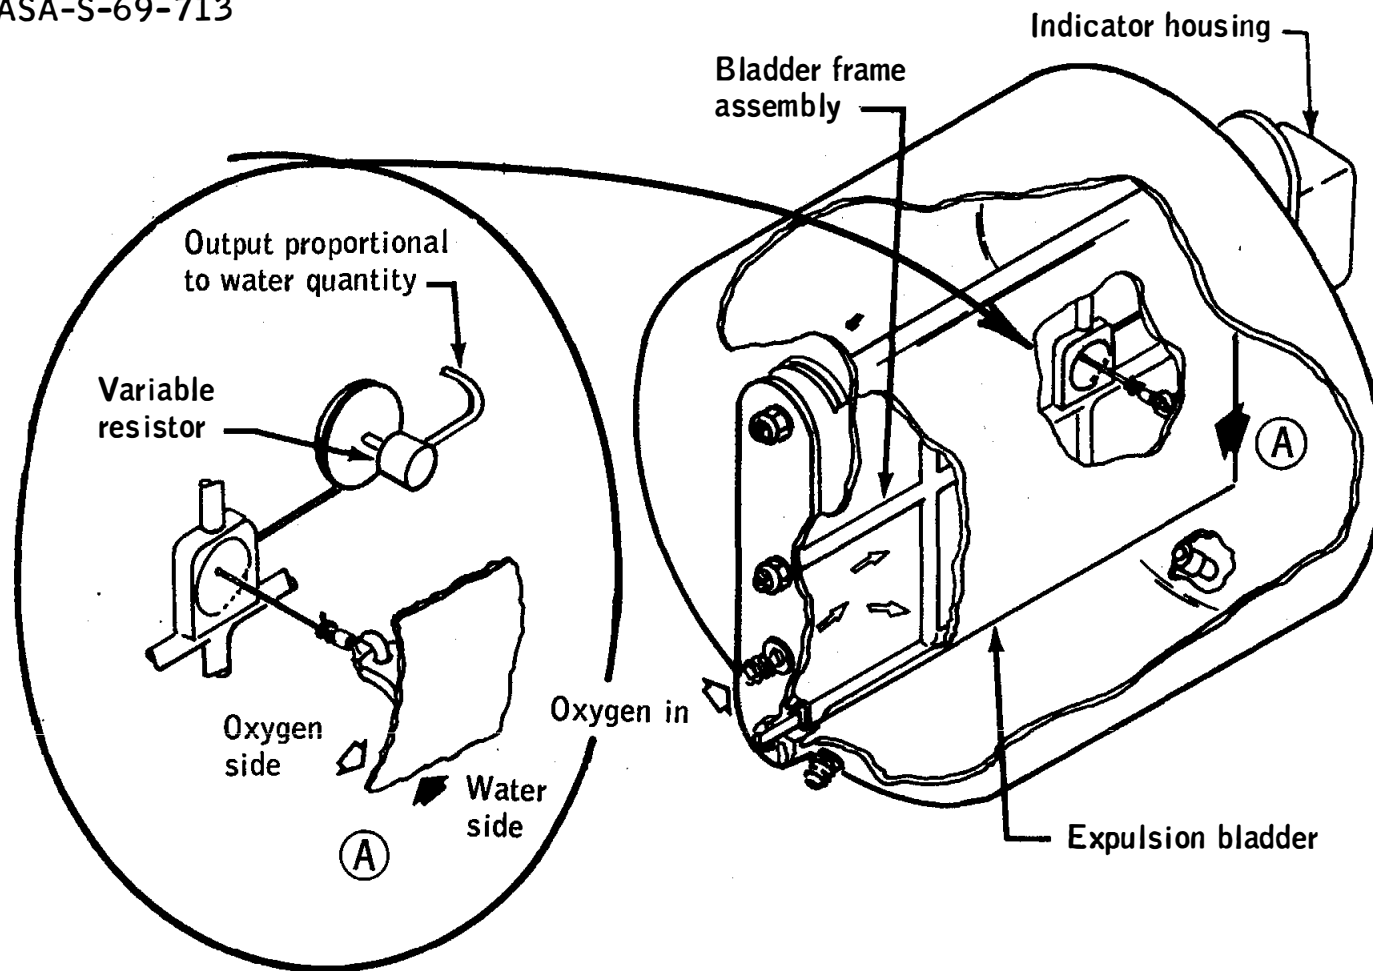
Figure 12-7.- Potable water tank.

Examination of the disassembled unit (fig. 12-7) revealed corrosion in the indicator housing, on the variable resistor, and on the actuator pulley, indicating moisture had been present in the oxygen side of the tank pressurization system. The actuator line was broken, probably as a result of postflight calibration with the pulley shaft frozen from corrosion. Analysis of the residue in the area indicated that the contaminant was urine and possibly water from the waste water tank. The contamination could have come through the oxygen bleed filter and orifice (fig. 12-8) into the indicator housing and bladder.
