NATIONAL AERONAUTICS AND SPACE ADMINISTRATION

MISSION OPERATIONS REPORT APOLLO 13

APRIL 28, 1970

PREPARED BY FLIGHT CONTROL DIVISION

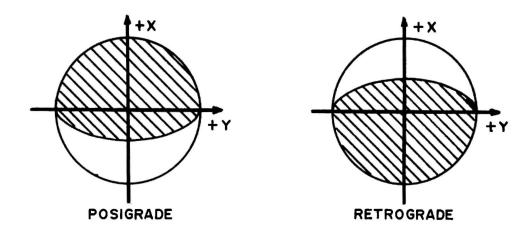
D. Since the crew could not find stars in the AOT before going behind the moon prior to PC+2, a method of executing the midcourse maneuvers was recommended using the earth terminator aligned on the horizontal line of the COAS with the COAS mounted in the FWD window looking down the LM +Z body axis. The sunlit part of the earth could be placed in the COAS as shown below for either a posigrade or retrograde burn.

MCC-5 was executed with the AGS body axis aligned using the retrograde alignment. A REFSMMAT OST 009 was computed that was equivalent to the above alignment, for use by other MOCR positions and by MPAD in their processors. AGS addresses 404, 405, 406 were loaded with zeros. The burn was monitored by 470R. The AGS accelerometer drift at $T_{\rm IGN}$ was determined to be -.2 fps. The burn was cutoff by the crew at 7.4 fps and trimmed to 7.6 in 470.

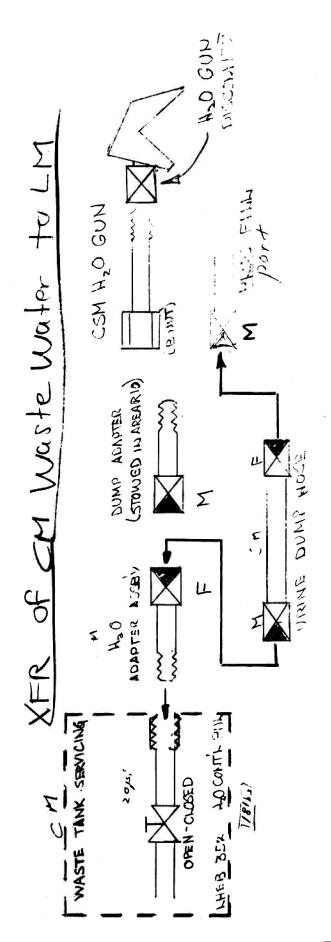
K. CM H20 TRANSFER TO LM PROCEDURE (\$ Steetch)

- 1. Pressurize H_2^0 tanks per procedure used for drinking gun H_2^0 .
- 2. Remove plug from port on waste tank servicing panel.
- 3. Install H_2O adapter assembly in port.
- 4. Connect urine dump hose to H_2^0 adapter assembly.
- 5. Connect PLSS to urine dump hose.
- 6. Open waste tank servicing vlv until PLSS is full (per sight glass) then close waste tank servicing vlv and disconnect PLSS.
- 7. Transfer H₂O from PLSS to LM H₂O tanks per procedure used to empty PLSS tanks originally.

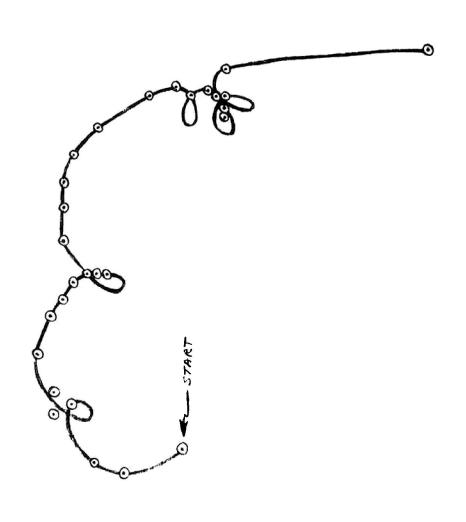
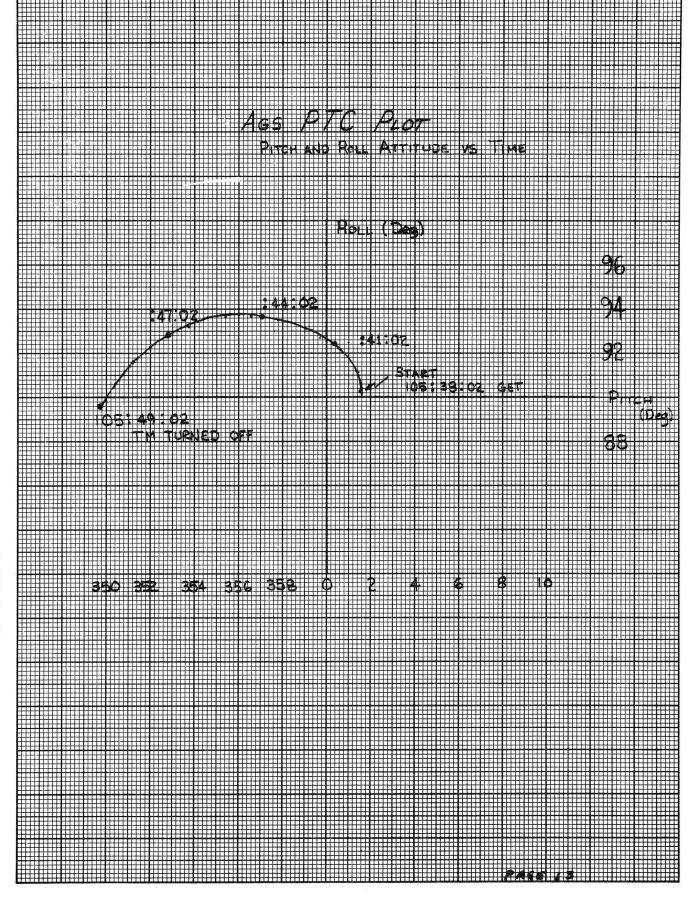
After MCC-4, an MIT recommended procedure was used to establish passive thermal control via the LM PGNS. The rates were nulled to less than 0.01 deg/sec by establishing a very slow minimum impulse limit cycle and then 30 clicks yaw right on the ACA to yield the slow plus vehicle yaw. 43 minutes of data indicated a 0.4 deg/sec yaw rate with the pitch and roll angles cycling about the starting point as shown in Figure ____. This PTC mode resembles closely the PTC modes established using the CM PGNS.
